## iCtp PW INFUSE Service tool update

Product code	Description	Implemented from Serial Number
10069600	PW3600	10069600-0033
10102450	PWINFUSE	10102450-0087
10107200	PWINFUSE XL	10107200-0005
10103500	PWINFUSE KIT	10103500-0010

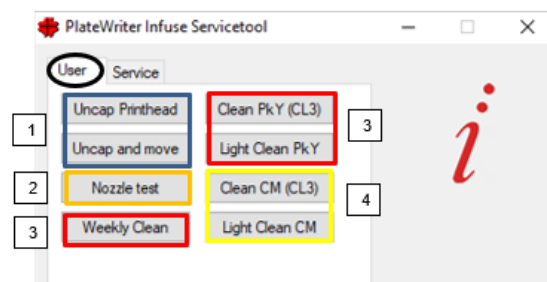
1. Uncap and Cap Print-head for maintenance or service.
2. Printing a nozzle test.
3. PK/Y Cleaning programs in 3 categories for maintenance.
4. Pump-Cap-Assy cleaning program for maintenance.

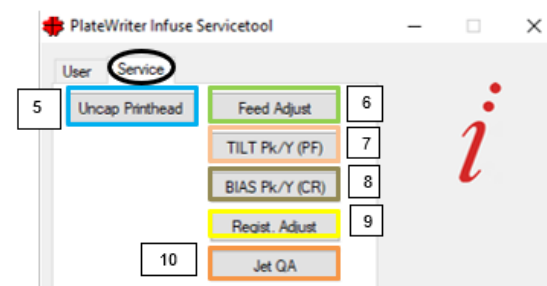
5. Uncap for maintenance or service
6. Adjustment of the printer feed
7. Head height and tilt (PF) adjustment
8. Print head slant (CR)/bias adjustment
9. Front registration system adjustment
10. Jet QA test job
